Manhole Inspection Summary

Manhole # S19C__016MH

Insp Date: **10/15/07 11:18 AM**

Location Address: **2101 MULBERRY ST**

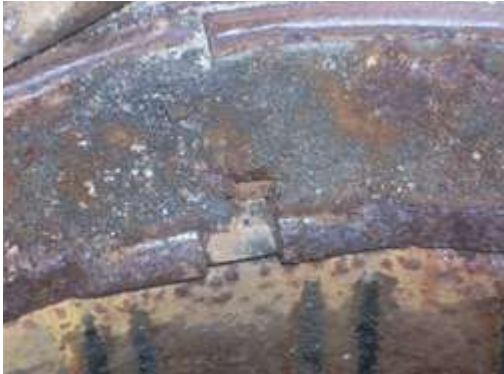
Defect 4

Comments **frame looks broken**

Condition: ☐ Sound ☒ **Cracked** ☐ Leaks

BROKEN FRAME

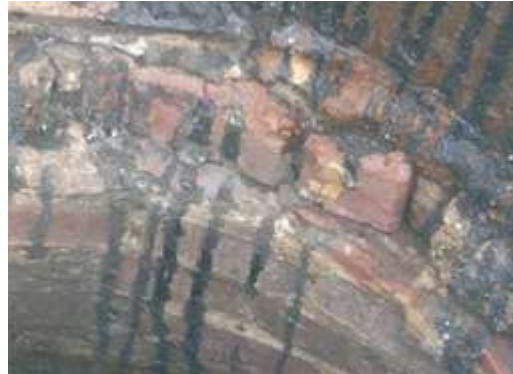
Defect 3

Condition: ☐ Sound ☐ Cracked ☐ Root Intrusion ☐ Loose Brick ☒ **Deteriorated**

DETERIORATION OF CHIMNEY

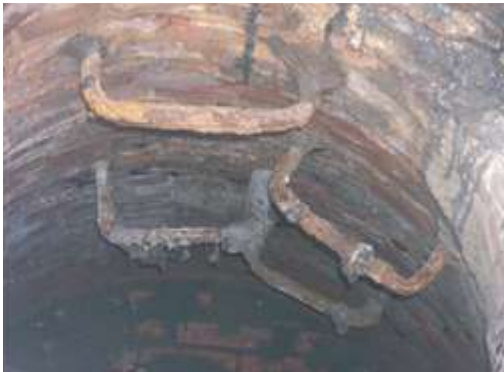
Defect 2

Count: **4** Missing: **0** ☒ **Corroded**

☒ **Evidence Of Surcharge** Depth: **3** (ft.) ☐ Active Surcharge Present

CORRODED STEPS AND SURCHARGE EVIDENCE

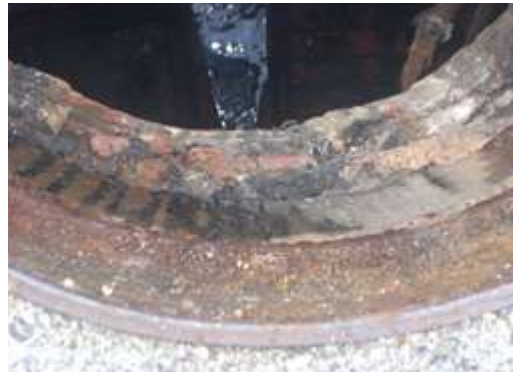
Defect 1

Offset: **2** (in.)

FRAME OFFSET

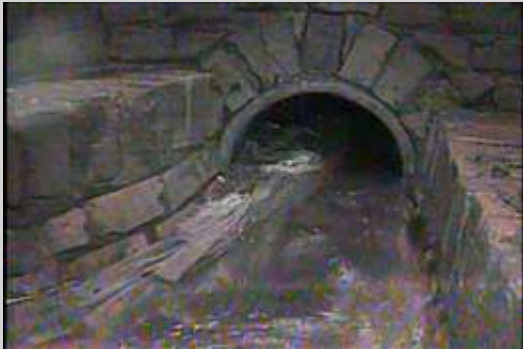
12 O'Clock Outflow

10 in. Circular Gravity Sewer
Pipe Out @ 12 O'Clock

Pipe Height: **9.6** (in.) Rod and Bar (Angled)
Pipe Material: **Clay** ☐ Pipe Lined
Invert Depth: **7.98** (ft.) Flow Characteristics: **Slow**
Deposits: ☐ None ☐ Mud ☐ Sludge ☒ **Debris** ☐ Grease
Silt Depth: **2** (in.) Deposits Extent: **Light**
Infiltration: **None** Pipe Seal Cond: **Sound**
